UNCOMMON NOISE SIGNATURES IN A WIND TUNNEL

R. Ramakrishnan, M. Rennie and S. Lau Aiolos Engineering Corporation, 2150 Islington Avenue, Toronto, M9P 3V4

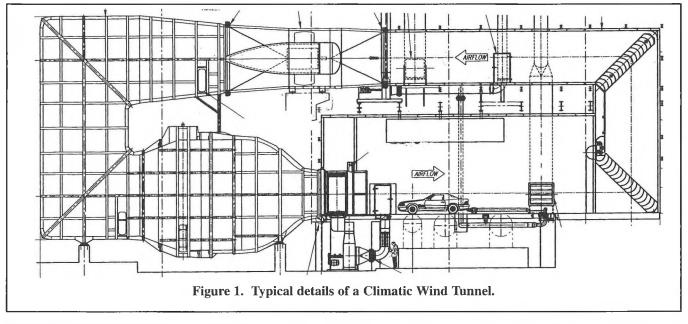
A schematic of the wind tunnel circuit is shown in Figure 1. The test section, where the test vehicle is located, is shown at the lower right of the figure. The control room is located next to the test section, at the same height as the test vehicle. The wind tunnel is an "overhead return" design, meaning that the return leg, which includes the main fan, is built on top of the test section. The air is guided through the wind tunnel circuit using flat-plate, circular-arc turning vanes located at each of the four corners. A heat exchanger is located in the settling chamber for temperature control. The temperature range of the facility is -40° C to $+50^{\circ}$ C.

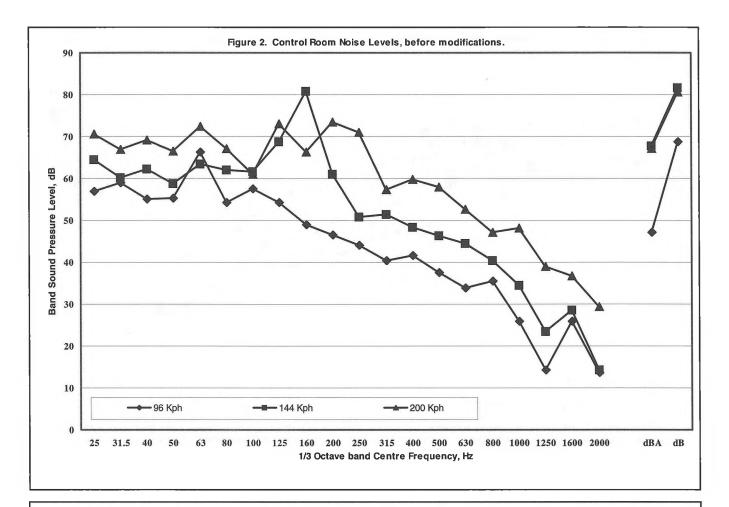
The noise levels measured in the control room for three testsection wind speeds are plotted in Figure 2. In addition to these data, the following observations were made:

- a) Strong tones were observed from a wind speed of 90 kph up to the facility maximum wind speed of 200 kph.
- b) The tone frequency increased with wind speed; however, the frequency was not a linear function of wind speed.
