# EFFECTS OF STRUCTURAL FLANKING ON APPARENT STC OF STEEL STUD WALL

Clair W. Wakefield, and Andrew P. Williamson

Wakefield Acoustics Ltd., 301-2250 Oak Bay Avenue, Victoria, B.C., Canada, V8R 1G5 email: [nonoise@shaw.ca](mailto:nonoise@shaw.ca)

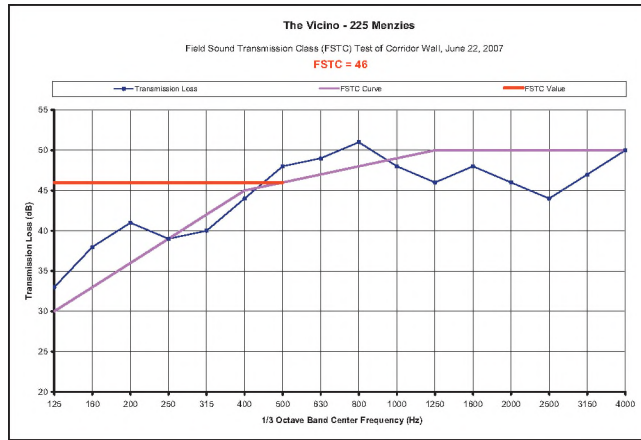
The initial test of the corridor wall yielded an Apparent STC (ASTC) of 46 (see Figure 2) whereas the 2006 BC Building Code (see Walls Number S9a and S9b rates this construction at STC 57 to 59. The mos

significant TL deficiencies were not in the lower 1/3-octave bands (125 to 250 Hz.) as is often the case, but rather between 1,250 and 3,150 Hz. These mid-to-high frequency TL deficiencies were not felt to be due to air-gap leakage since the TL performance recovered again in the 4,000 Hz. 1/3-octave band.

Figure 2; Results of Initial Apparent STC (ASTC) Test of Corridor Wall Showing Mid-High Frequency TL Deficiencies

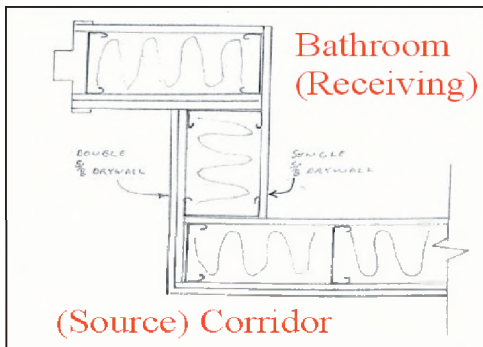
Suspecting that construction flaws might be responsible for these TL deficiencies, a section of wall was opened up on the bathroom side to confirm the presence of cavity insulation and the absence of any structural bridging (by waste pipes etc.) across the cavity. No such construction flaws were discovered. This then left the possibility that structural flanking was the culprit, an opinion that was subsequently reinforced by a conversation with a specialist in this area – Dr. Trevor Nightingale of the NRC.

Figure 3; Detail of Junction between Corridor Test Wall and Side Wall showing Bridging of Wall Cavity by Gypsum Board.

As seen in Figure 3, the wall cavity is blocked off with one or two layers of gypsum board at each corner - apparently for flame spread prevention, but also likely for convenience during construction. Gypsum board then bridges the cavity at the corners and allows structure-borne sound to pass through it more efficiently that would be the case if the only connections were provided by lightweight steel studs.

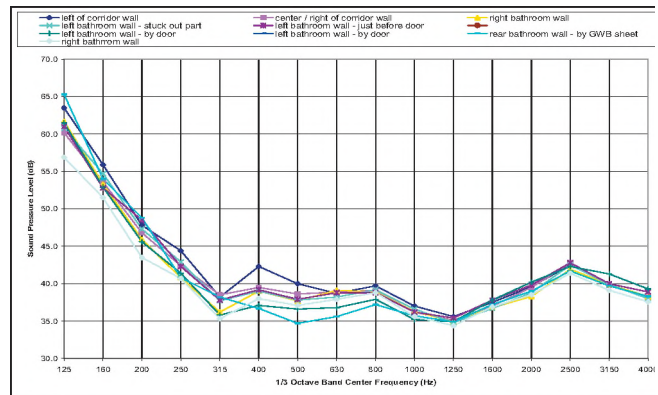
At the time of the second test, a series of spatially averaged SPL measurements were made within about 50 mm the various bathroom wall surfaces to explore their relative significance to the overall sound radiation into the space. Figure 4 shows the various 1/3-octave band SPL spectra obtained. Note the consistency of the sound levels particularly at and above 1000 Hz., indicating that the level of induced vibration in the two side walls were no significantly different from those in the test wall.

Figure 4; Results of Near-Field SPL Scans Over Wall Surfaces
