MEASUREMENT OF SUDDEN UNEXPLAINED HIGH-LEVEL NOISE EVENTS WITHIN RESIDENTIAL DWELLINGS

Roderick Mackenzie¹ and R. Sean Smith¹

¹Building Performance Centre, Institute for Sustainable Construction, Edinburgh Napier University, 42 Colinton Road, Edinburgh, United Kingdom, EH10 5BT, ro.mackenzie@napier.ac.uk

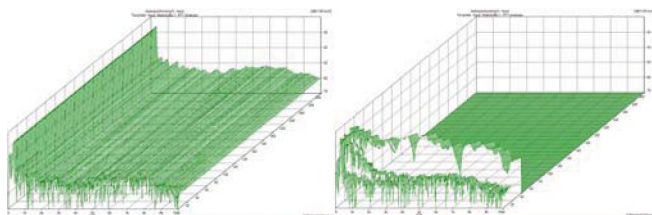
During investigative visits, some sites exhibited “naturally” occurring “noise events,” either following the internal heating being turned on (~90 mins later, Site A), cooker being turned on in the Kitchen (~20 mins later, Site D), or the activation of a shower in a bathroom (~ 10 mins later, Site E). These incidents would suggest a relationship with relatively rapid temperature and/or pressure increase and the “noise event” occurrence. An example of the “noise event” from Site E is show in Figure 1, showing the change from the background noise level within a 30 second recording.

Figure 1. Waterfall FFT display of accelerometer signal from bathroom at Site E showing the background signal (left) and a “noise event” approximately 13 minutes later (right).

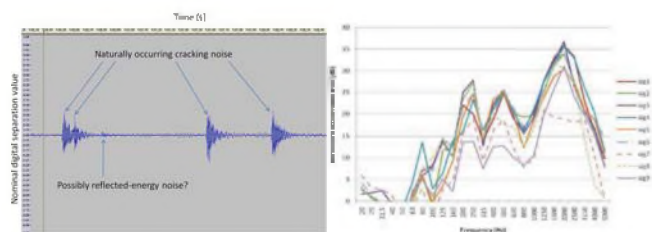
It was observed that “noise events” would often occur in split-second clusters of typically 2 or 3 events, as can be seen in Figure 2. Figure 2 also shows the FFT signal level increases from background levels caused by the first “noise event” of Figure 2.

Figure 2. Four “noise events” within 1.5 seconds, induced after heating the living room of Site A for c.90 mins. Time trace (left) and 1/3-octave signal responses of the first event minus background (right).

- In-plane waves would be formed, which would carry along the board with some minor dissipation at board edges, but be very similar in its shape and measured values across the ceiling due to less impedance from the truss junctions.
- Flexural waves would also be formed and would be expected to peak at or near the critical frequency of the gypsum board, approx 2000Hz to 3150Hz for standard gypsum board thickness 15mm to 12.5mm.

Both of these facets can be seen in Figure 2.

It is suggested that further future analysis is undertaken investigating standard plasterboard types and changes to manufactured material properties which have occurred in recent years. Replacing the standard ceiling boards with high density boards and mounting these via resilient ceiling bars has eliminated the noise sources on the study sites.
