CASE STUDIES: EFFECT OF FASTENERS BRIDGING RESILIENT CHANNELS ON AIIC PERFORMANCE IN WOOD-FRAMED CONDOMINIUMS

Pier-Gui Lalonde*¹

¹Swallow Acoustic Consultants Limited, Ottawa, Ontario, Canada.

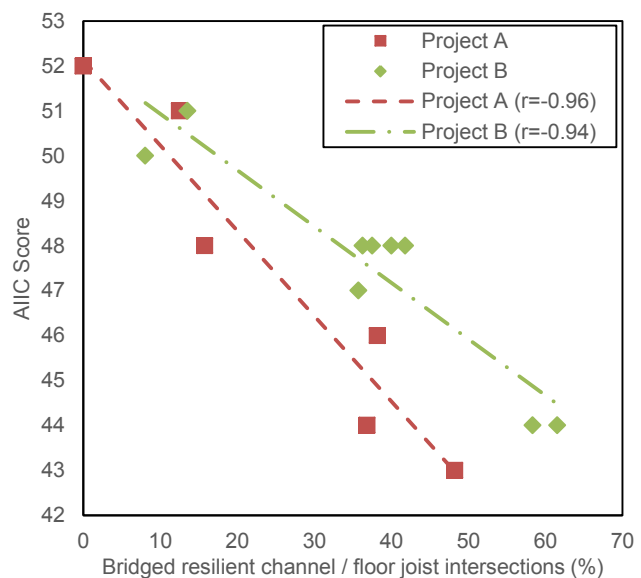
Apparent Impact Insulation Class (AIIC) measurements, as well as inspection of the floor-ceiling construction with ceiling drywall removed, were completed within several units. It was confirmed that many drywall fasteners penetrated floor joists, thus bridging resilient channels and negating their proper function.

For both projects discussed in this paper, a strong correlation was found between the percentage of resilient channel / floor joist intersections with bridging fasteners, and the AIIC score.

Figure 1 below shows the relationship between the rate of bridged resilient channel / floor joist intersections and the AIIC score for both Project A and Project B. Figure 1 also includes best-fit lines and correlation coefficients (r) for each project. The data show that AIIC performance drops significantly as the occurrence of bridging fasteners increases. In Project A, a rate of 16% reduced AIIC performance by four points, and a rate of 48% reduced AIIC performance by nine points, relative to one test scoring AIIC 52 in which no errant fasteners were found. In Project B, AIIC performance was reduced by two points for a rate of 8%, and eight points for rates of 58% and 62%, relative to the minimum performance expectation of AIIC 52.

Figure 1: Relationship between AIIC scores and the percentage of bridged resilient channel / floor joist intersections
