CASE STUDY: RETROFITTED SOLUTION TO ADDRESS SOUND FLANKING VIA WINDOW MULLIONS OF STACKED RESIDENCES

Pier-Gui Lalonde*¹

¹Integral DX Engineering Limited, Ottawa, Ontario, Canada

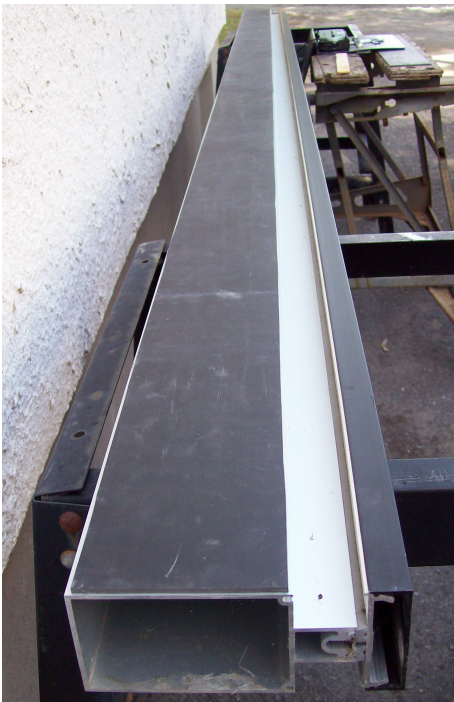
Finally, the insulation was removed, and tests were completed with one and two of the mullion surfaces covered with a barium-loaded vinyl product, which had been selected for a high surface weight (2.0 lb/ft², or approximately 9.8 kg/m²). The stimulus and measurements were both located on surfaces without the mass-loaded barrier treatment. The acceleration response was reduced by approximately a factor of 2 with two of the three suite-facing surfaces treated, compared to the un-treated condition.

Figure 1: Validation testing setup, with mass-loaded barrier applied to one of the window mullion surfaces.

The testing results showed measurable but modest reductions of vibration transmission by adding mass-loaded barriers under the test conditions. Various adhesives were also tested for their suitability to hold the mass-loaded barrier in place and ease of removal.

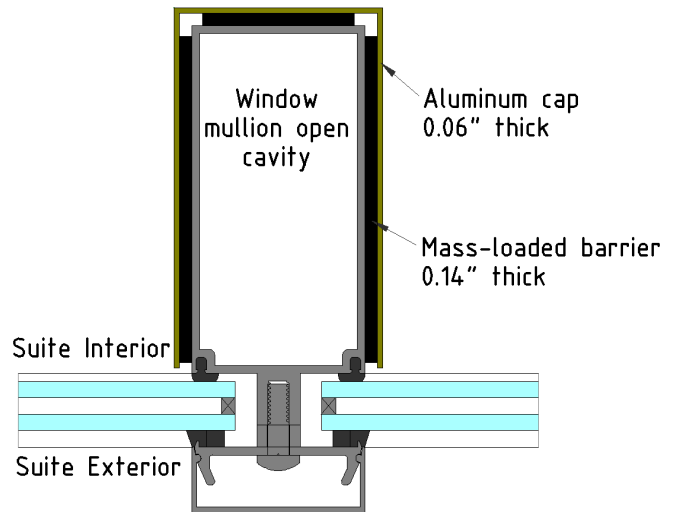
Figure 2: Cross-section of window mullion with acoustic treatment.

The final noise mitigation plan was to affix a mass-loaded barrier to each of the three suite-facing surfaces of each vertical window mullion within the third floor suite. The mass-loaded barriers would then be covered with

custom-fabricated aluminium caps, colour-matched to the window frames. To ensure a more consistent look, some horizontal window mullions also received the same treatment. Compared to the validation testing, the mass-loaded barriers would cover a shorter span, but each of the three suite-facing surfaces would receive the treatment (compared to only two of three for the testing). The aluminium caps would provide additional mass, which could only further reduce airborne and structure-borne sound transfer.
