COMPLEXITIES OF CURTAIN WALL FLANKING TRANSMISSION - A CASE STUDY

Kelly Kruger ^{*1}, Robert Ogle^{†1}

¹Building Science Engineering, Edmonton, Alberta, Canada

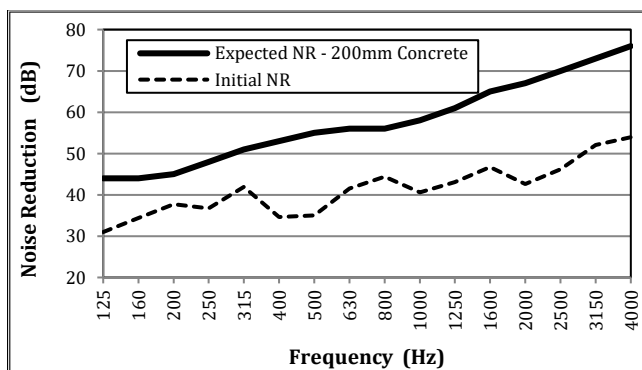
The authors were recently involved in the acoustic commissioning of a university building where the sound isolation between floors was considered to be critical. A Noise Isolation Class of NIC 55 - 60 was required in order to allow music practice rooms to be located directly below conventional lecture rooms. Adequate acoustic isolation should have been achieved if the sound transmission was entirely determined by the 200 mm thick, post-tensioned concrete floor that separates the classrooms. The initial sound isolation, NIC 42, was found to be well below expectations, as shown on Figure 1.

Figure 1: Expected vs measured noise reduction

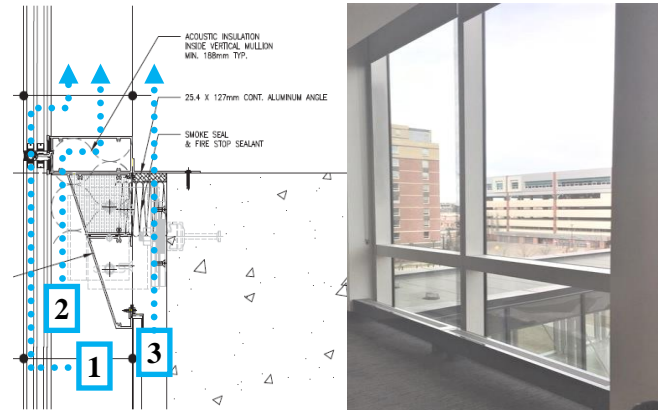
Figure 2: Curtain Wall Flanking Paths.

Flanking can occur along several paths. Path 1 shows the transmission from the glazing on the lower floor level through the spacer and into the glazing on the upper floor. Path 2 shows the transmission directly through the horizontal mullion. Path 3 shows the transmission through the gap between the curtain wall and the floor slab.

An inspection of the curtain wall/floor junction revealed that the fire stop had not been fully installed (Flanking Path 3). This left a significant opening at the edge of the floor slab that was only blocked by carpeting. It was assumed that this gap was the most significant flanking path. It was therefore dealt with first by inserting two layers of fire resistant, mass loaded joint filler, with mineral wool inserted between layers. Treating Flanking Path 3 provided a modest improvement to NIC 46.

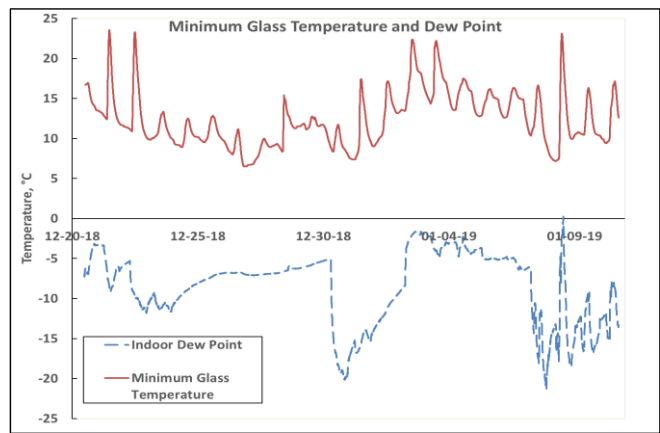
In order to confirm if condensation would be problematic, temperature probes were used to monitor the glass temperature of both a typical existing IG unit, and an adjacent unit covered using gypsum board of roughly the same insulation value as the proposed inner glass panel. Data loggers were also used to measure the interior and exterior relative humidity (RH) for a period from December 20th 2018 to January 10th 2019. During this time, a minimum glass temperature of 6.5° C and a maximum dew point temperature of 0.2° C were measured (not concurrently) and are shown on Figure 3. Maximum interior RH levels during both occupied and unoccupied classroom times were found to be less than 25%. Using the collected data, a “worst case scenario” of a -30° C exterior temperature with interior conditions of 25° C and 25% RH was evaluated. In this scenario the dew point of the interior air was 3.6° C and the minimum glass temperature was 5° C. Therefore under these design conditions, condensation would not occur.

Given these findings we concluded that the introduction of the interior glass panels would not result in condensation problems.

Figure 3: Minimum insulated glass temperature vs. dew point

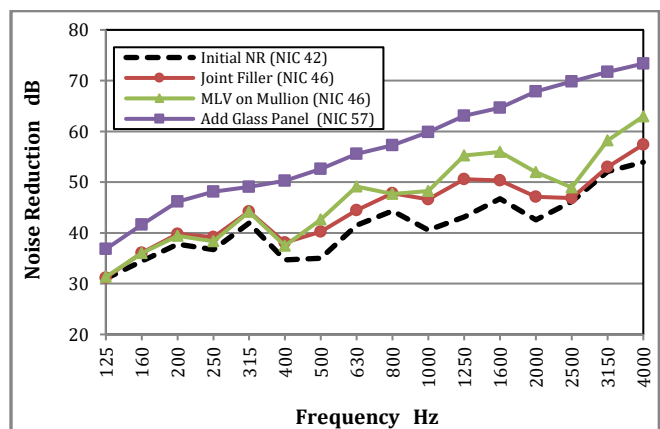
Figure 4 summarizes the improvement that occurred after each step of mitigating the flanking through the various paths. Some flanking from the curtain wall is still evident but any further modifications to the existing construction are no longer thought to be practical.

Figure 4: Improvement due to treatment of Flanking Paths

Finally, a new glass panel was installed to cover the entire lower section of the curtain wall, thereby reducing the contribution of the last major flanking path. The lower mullions were clad with a layer of MLV that incorporated a sound absorptive foam layer exposed to the cavity between the curtain wall and the new glass panel. A significant improvement in sound isolation (NIC 57) was achieved.
