# SOUND FLANKING THROUGH COMMON LOW-VOLTAGE ELECTRICAL CONDUIT IN MULTI-FAMILY RESIDENTIAL BUILDINGS

Michael Kundakcioglu <sup>\*1</sup>, Adam Doiron <sup>†1</sup> and Jessica Tinianov <sup>‡1</sup>

<sup>1</sup> HGC Engineering, Mississauga, Ontario, Canada

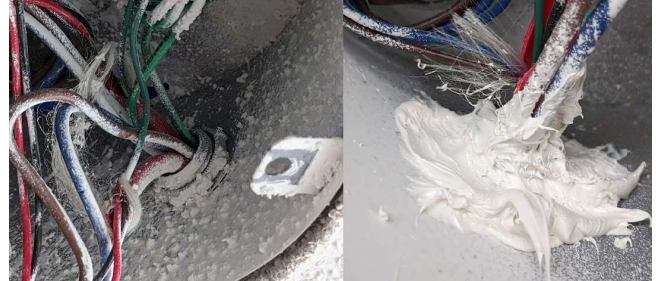
**Figure 1:** Unsealed Conduit Opening in Fire Alarm Junction Box (Left), and Conduit Opening after Applying Sealant (Right)

there is common conduit routed between suites, rectification of the issue is feasible. The application of non-resilient caulking at both ends of the conduit, such that the opening is fully sealed (see Figure 1), has been found as sufficient to mitigate this weakness such that the sound insulation performance of typical suite-demising wall assemblies is not distinctly affected by this flanking path.

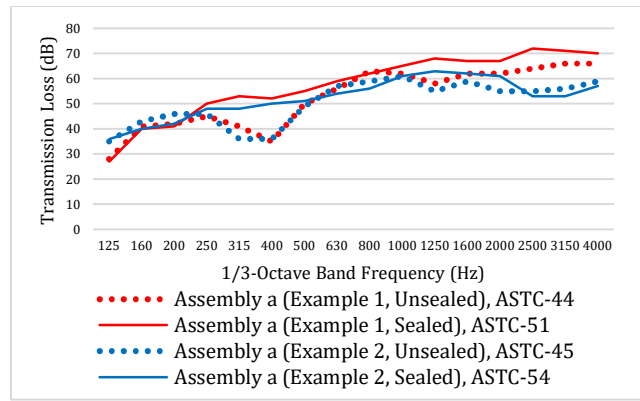
There is no publicly available published test data for the above assembly; however, based on numerous in-situ sound insulation tests, this assembly is expected to achieve a rating in the low STC-50s. Figure 2 shows the results of measurements conducted on two sites where the conduit opening at the junction box was found to be unsealed, before and after the opening was sealed with caulking.

Figure 2: Steel Stud Walls Transmission Loss Results

however, and the conduit openings left unsealed, sound flanking through this path is demonstrated to degrade the sound insulation performance of these assemblies significantly, ranging in severity from five to ten STC points across the tests presented above. The method of sealing the conduit opening with caulking (as shown on the right side of Figure 1) is not generally cost-prohibitive, and should be included in the scope of work for the relevant contractor for construction of all multi-family residences where this condition exists.

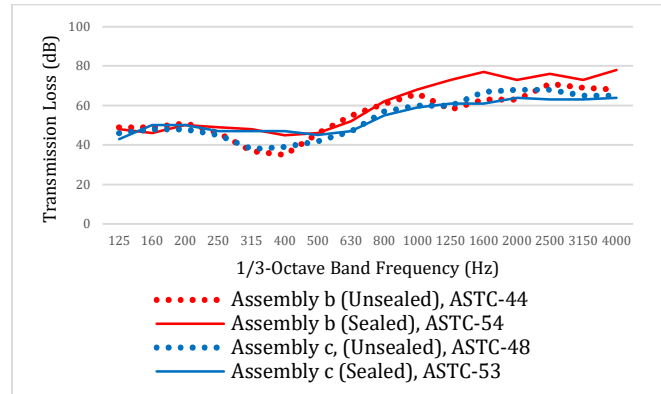
With adequately laminated drywall and no other construction deficiencies, this assembly achieves in-situ performance ratings above ASTC-50, most typically in the range of ASTC-53 to ASTC-55. Again, the figure below shows the results of measurements conducted on two sites before and after the conduit opening was sealed with caulking.

Figure 3: Poured Concrete Walls Transmission Loss Results
