# Subsynchronous Vibration of an Auxiliary Turbine

B. Alavi and C. Hugh

Ontario Hydro  
700 University Avenue  
Toronto, Ontario M5G 1X6

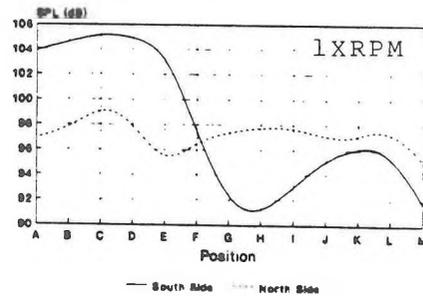
Fig. 3

distance of 10 inches from the pump and turbine casings at discrete locations extending from the pump inboard bearing to the turbine H.P. bearing (see table 1). Figures 3 and 4 represent a typical noise measurements taken by a real time analyzer. It was noticed in all our measurements that a distinct tone was detectable around the unit at one and two times the rpm when the unit was operating at full load. The noise radiated due to  $1$ \*rpm appeared to have maximum amplitude close to the south side of the coupling and the noise radiated at  $2$ \*rpm had a maximum level in the close proximity of the third and fourth stage turbine.
