FLANKING IN WAREHOUSE TO RESIDENTIAL CONVERSIONS

D.B. Larson and R.A. Strachan
Brown Strachan Associates
Two Yaletown Square
1290 Homer Street
Vancouver, B.C., Canada. V6B 2Y5

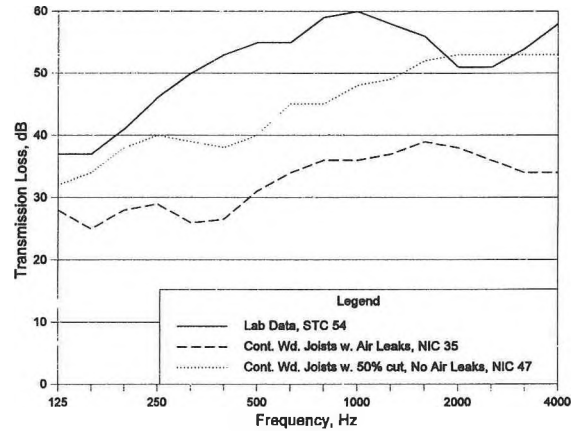
Figure 1: Effect of Flanking on Party Wall Performance

Testing indicated that the floor isolation was NIC 30 with low frequency deficiencies between 160 Hz and 250 Hz. The measured wall isolation was NIC 35. Mid frequency deficiencies between 250 Hz and 1000 Hz were attributed to air leaks between the wall and adjacent columns. Vibration measurements indicated that flanking in the continuous floor and roof accounted for the low frequency deficiencies.

Later tests between rooms with an exposed wood roof of full cut 2 x 4's on edge perpendicular to the party wall indicated NIC 35. The isolation at 250 Hz to 300 Hz was only 25 decibels, which is characteristic of coincidence in 2 x 4's. Where the wood studs were parallel to the party wall, NIC 39 was measured, with 32 decibels at 250 Hz to 300 Hz. While these tests were affected at high

frequencies by air leaks, they indicate the severe limitation of continuity in 2 x 4's oriented perpendicular to a wall.

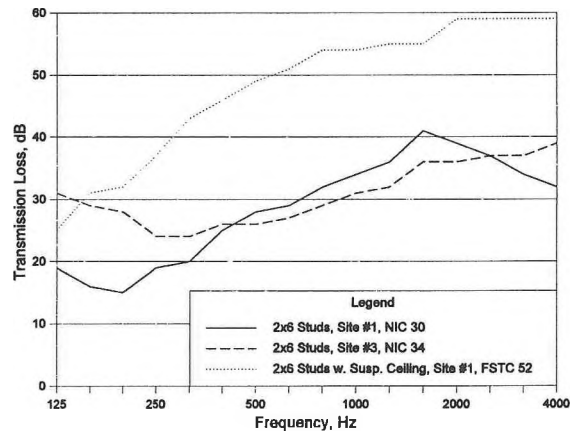
Figure 2: Effect of Suspended Ceiling Treatment

The transmission loss of the floors was improved to meet the Code STC 50 using a suspended drywall ceiling. The suspended ceiling construction at site #1 (without a concrete topping) was two layers of 1/2" drywall with a nominal 6" air gap. The metal framing was rigidly attached to the existing (12" deep) perimeter beams and the cavity was insulated with R12 home insulation. A central neoprene isolator support was provided on larger spans (15 ft.). The measured isolation was FSTC 52. A concrete topping alone generally increases the rating to about STC 46 and a concrete topping with a single drywall ceiling to about STC 54.
