# PRACTICAL ASPECTS OF IMPLEMENTING SOUND ISOLATION AND NOISE CONTROL

A.D. Lightstone, Ph.D., P.Eng.  
Valcoustics Canada Ltd., 30 Wertheim Court, Unit 25  
Richmond Hill, Ontario L4B 1B9 (416)764-5223

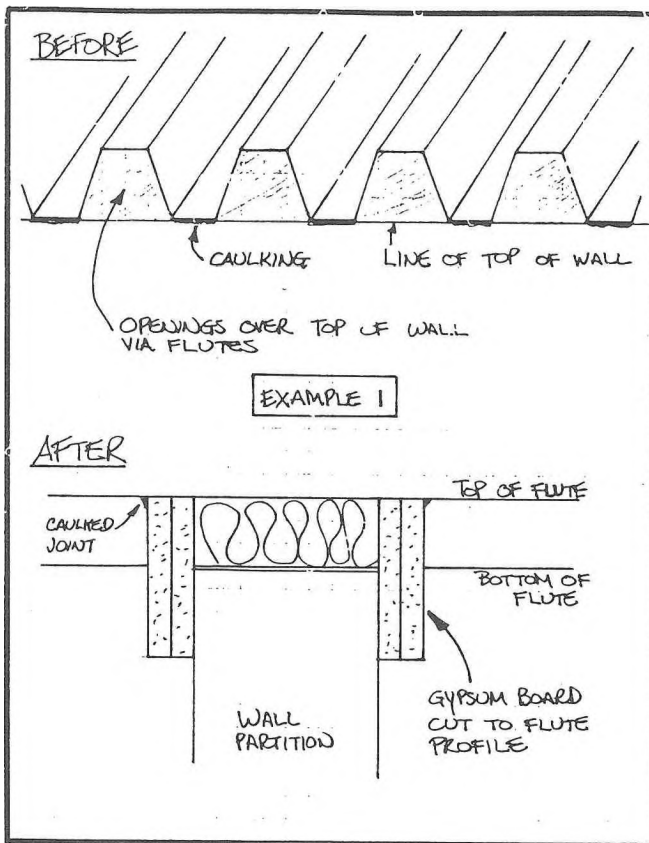
Example 1:

Gypsum board (GWB) partition between classrooms to extend to fluted deck above. GWB stopped at bottom of flutes and joint carefully caulked. Openings left through wall via flutes.

Solution: Close flutes with surface-applied GWB precut to flute profile.

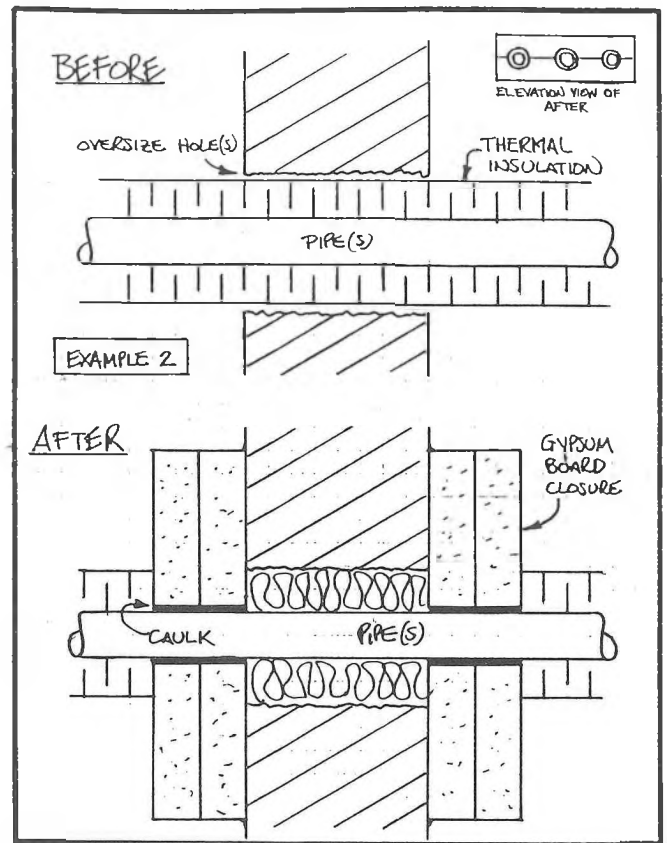
Example 2:

Back-to-back fan coil units on common (GWB) wall between hotel rooms. Pipe penetrations to be specially sleeved and sealed to maintain acoustical and fire ratings. Contractor simply cut oversized holes and used thermal insulation over pipes. Very little working room between back of units and wall.

Solution: Cut proper pipe holes in GWB; cut in half through pipe holes; pre-caulk all joints; surface mount multiple layers on both sides of wall; seal all edges.

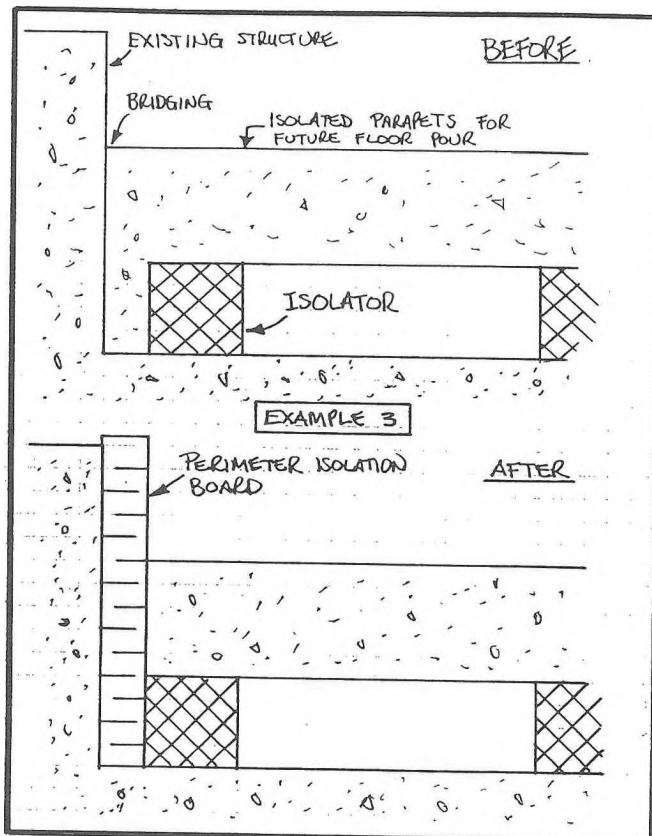
Example 3:

Floating concrete floor for tv studio, on concrete parapets (on isolators) to match existing floor level. Section of isolated parapets poured directly against existing structure, forgetting perimeter isolation board.

Solution: Saw cut joint; clean out; insert isolation board.

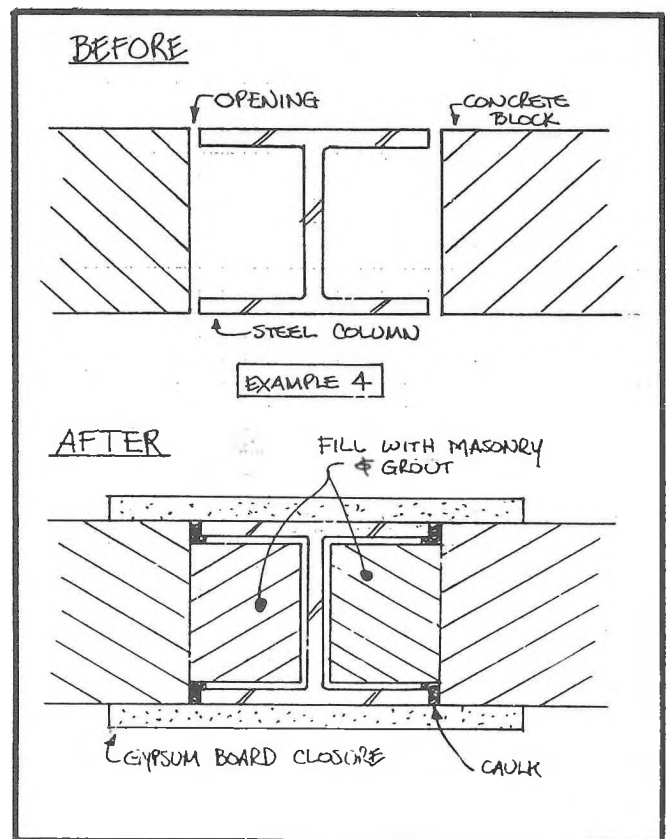
Example 4:

Concrete block wall integrated with steel columns. As built - gap between vertical edges of concrete block and columns, leaving openings through wall around columns.

Solution: Fill cavity with sawcut block, rubble, and grout solid. In some cases, build out column cap of concrete block or GWB.
