Barry McKinnon

Barron Kennedy Lyzun & Associates Ltd., North Vancouver, BC V7M 3G4

0 INTRODUCTION

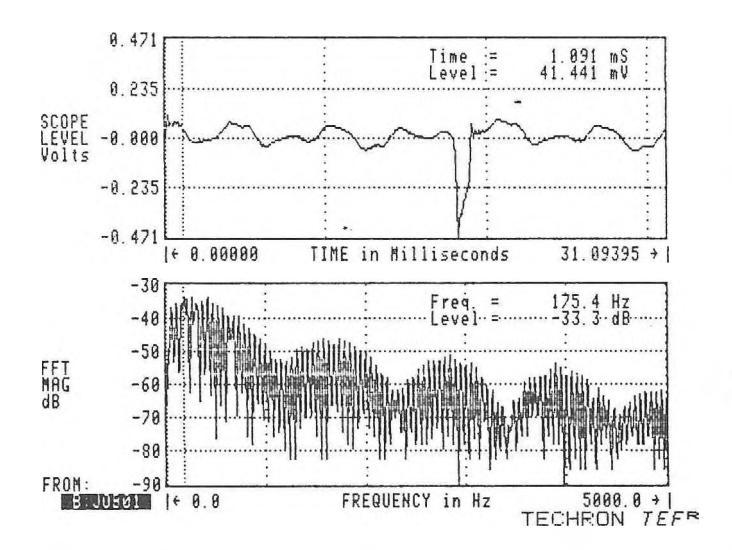
The most likely noise source, the fluorescent ballasts, were The most likely noise source, the fluorescent ballasts, were quickly eliminated as the cause of the noise. It was necessary to get within 300mm of the fixtures before a single LED would light, corresponding to a level of -31dB A/m. The noisiest area was in the immediate vicinity of the Director's office and the adjacent small conference room. The conference room was equipped with a VCR and a 28" TV monitor, which when powered up, produced a very broadband noise spectrum typical of the square waves produced in the switching power supplies of modern TV monitors. The FFT spectrum is shown below in Figure #1. The field was quite uniform around the monitor, and the receive level was very dependent upon the orientation of pickup coil. Those people with hearing aids could find a head orientation that would minimize the graduate the Gald structure was a birth and for the second pickup level, but the field strength was as high as 5 LEDs within 1500mm of the monitor.

The PC type computer in Ruth Warick's office produced a similar spectrum of noise. The CRT monitor was responsible for a significant portion of the noise, but the CPU was contributing a continual background "hash" of noise as well. This was measured in excess of 5 LEDs at the operational distance of arm's length to the computer keyboard.

Fig. 1. Noise spectrum of TV monitor.

The problems encountered with TV and computer monitors, and computer CPU's may affect the choice and location of this type of electronic hardware. Flat screen LCD panels should have substantially less EMI than the CRT type, and may be a better choice in offices where the use of a T-coil hearing aid is required. TV monitors will always be a problem, as the CRT will be with us for ouite some time before flat screen technology becomes affordable.

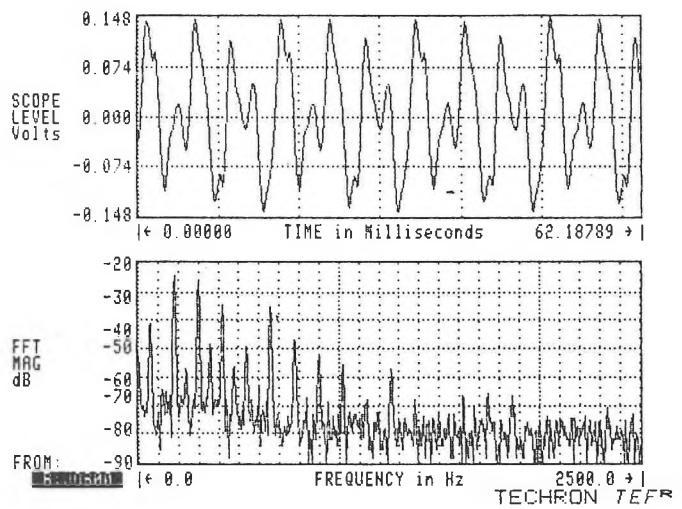
Over and above these two specific broadband noise sources, there was a sharply localized hum that was definitely related to the AC line frequency. We tracked the highest signal strength to a line at floor level that made a ninety degree bend in the corner of the office, and a second ninety degree bend just outside the office, along the wall of the conference room. Reviewing the electrical drawings once again did not present any likely culprits for electrical noise in this location. We went into the basement of the building to look for the alectrical service that may be causing the building to look for the electrical service that may be causing the EMI.

stronger fundamental. The underside of the slab was accessible throughout the area where the EMI was tracked, as the basement was undeveloped. The building heating services entered directly under the Director's office, tight to the underside of the slab. There was a steam pipe and a hot and cold water return following the path, but no electrical service evident. We were informed that there was no in-slab electrical in the building, which left only the pipes. When we measured up tight to the nine wran insulation we found that the slab electrical in the building, which left only the pipes. When we measured up tight to the pipe wrap insulation we found that the pipes were definitely the source of the EMI. The FSM went off scale within 25mm of the pipe insulation on the steam pipe which seemed to carry the highest current. Calculating backwards from the FSM indicators (which are only bandwidth rated for 300Hz-3300Hz) the current in the pipe was in the order of 1 Ampere in the FSM bandwidth. The FFT display in Figure #2 shows the 60Hz AC line frequency fundamental some 15dB below the 300Hz harmonic which falls within the FSM bandwidth. The noise spectrum suggests the sum of ground currents from a variety of devices and phases, producing high harmonic content.

The building ground in this new facility was likely superior to the buildings nearby that were connected together through the steam and water pipes. We were measuring ground current from other buildings flowing to the electrical ground for Brock Hall. The ideal solution would have been to install flexible, non-conductive isolators in the linea which would have previded the provided these isolators in the lines which would have provided the required break in the ground path. This was not possible at this stage of the building construction. The mitigating solution chosen by the contractor was a ground at the building entry, which did, at least, improve the condition for the largest number of people.

Fig 2. AC Line related noise spectrum.

Since the pipes passed through a mechanical room immediately adjacent to a large distribution transformer, we thought that there may be some induction into the pipes which formed a huge loop back to the University's Physical plant. Attempts to ground the pipes at the mechanical room actually increased the field strength, indicating that the current flow upon current to be building to indicating that the current flow was from outside the building to the lower impedance ground point. Attempts to ground the pipe at the service entry point decreased the field strength along the pipe by approximately 4dB, but increased the field strength in the immediate vicinity of the Director's office.

The measures taken to alleviate the EMI were limited to those that were non-invasive to the building structure. There was no opportunity to try magnetic shielding above the piping carrying the current. Because the currents on the pipes were not extremely high, there was no concern for increased corrosion, so there was no secondary justification for having non-conductive isolators installed in the pipes to break the current flow.
