STUDY OF VIBRATION TRANSMISSION ON A PAVER'S HAND HAMMER

Uwe Kaulbars¹ and Nastaran Raffler¹

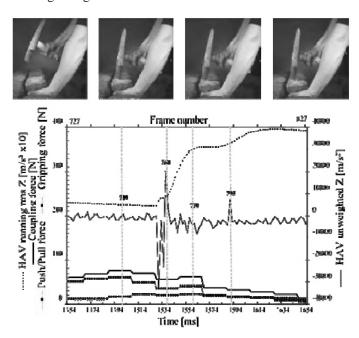
The summary of all measured values (Figure 1) shows the coupling forces with the unweighted and weighted

acceleration and the position of the hammer during the impact process. For technical reasons, the coupling forces were measured at intervals of 20 ms. The push force is decisive for the force acting outwardly. It acts in the direction of impact, and is oriented in the direction of action of the vibration/recoil. During the impact event, the push force is 17 N and the grip force 49 N. The recordings by the high-speed camera clearly show the transmission of the shock into the wrist, which is accompanied by a rotating/tilting motion.

Figure 1: Summary of the measured values in the phases of the impact process (example)

In order to prevent cable movements from causing contamination effects when the hammer was lifted, the vibration exposure was analysed separately for each impact. In order to permit comparison between the individual impacts, each impact was integrated over one second. Altogether, 12 series of measurements were conducted. The results for the energy-equivalent average values over one second were averaged arithmetically over the individual impacts. The resulting average frequency-weighted acceleration a_{hw} was 24.4 m/s². The unweighted acceleration measured at the hammer handle attained peak values of up to 30,000 m/s². The impact event was however very brief. and had already subsided after approximately 20 to 30 ms. The mean value for the push/pull force F_{pu} across all series of measurements was 22.3 ± 8.5 N, and for the grip force F_{gr} 32.8 ± 8.8 N. The coupling force F_{cp} averaged from the individual measurements was 55.1 ± 14.0 N. Since the vibration-free components during raising and lowering of the hammer were included in this average, the forces arising during the impact phase were determined separately.
