NOISE CONTROL ISSUES IN A STEEL-FRAME INSTITUTIONAL BUILDING

Clair W. Wakefield ¹

¹Senior Consultant, RWDI (formerly Wakefield Acoustics Ltd.)
301-2250 Oak Bay Avenue, Victoria, B.C. V8R 1G5

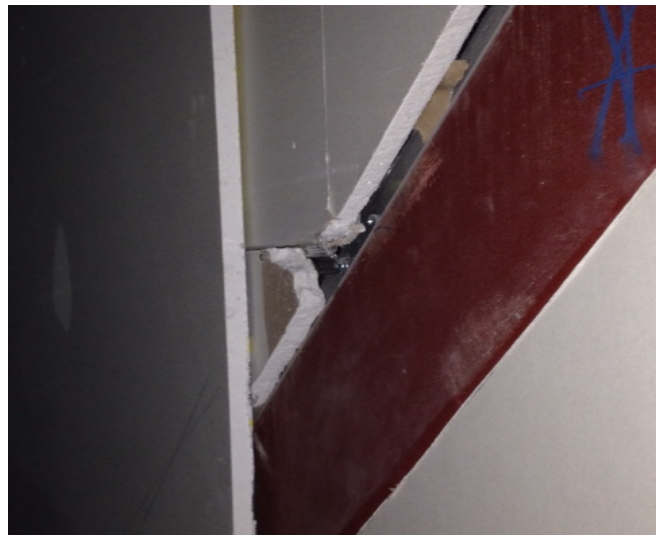
The structural steel framing (columns and cross bracing) supporting the building had to be accommodated within the cavities of the steel stud and gypsum board demising walls. While these demising walls do not support the building, the heights of the walls separating the various laboratories as well as the band, choral, and dance spaces, required that the studs be load-bearing (i.e., not lightweight). The acoustical separation was then compromised in two ways :

- Excessive transmission via the load-bearing studs,
- Resilient channel ineffective - "squashed" between steel framing and gypsum board.

The wall cavities should have been wide enough to accommodate the steel framing elements, however, it was subsequently learned that the framing sizes had been increased late in the design process and it is possible that the wall cavity widths were not adjusted accordingly. The effect was to limit the Apparent Sound Transmission Class (ASTC) ratings achieved in field tests as follows:

- Wall between laboratories achieved ASTC 37 when lab-rated objective was STC 53,
- Wall between Theatre and Atrium achieved ASTC 37 when lab-rated objective was STC 60.

Figure 1 shows an example of the problems created in accommodating the steel cross braces within the Theatre/Atrium wall.

Figure 1: Bridging of Theatre/Atrium wall cavity by structural steel cross bracing.

The problems created in certain demising walls by the presence of structural steel elements and inadequate cavity width were overcome by creating separate, free-standing (self-supporting) barrier layers (steel studs and gypsum board or dense board) over one side of each wall. The newly created wall cavities were insulated. In some cases the existing gypsum board surface was first removed so that a wider cavity could be created, in other cases, where space was less critical, the existing gypsum board was retained. The most challenging situation was that between the Theatre and the Atrium, both because of the size of the wall (see Figure 3) and because of the high STC objective. For this reason, a localized mock-up section was first created and tested before the entire wall was treated.

These wall treatments generally increase classroom wall performance from about ASTC 37 to ASTC 47. In the case of the Theatre/Atrium wall, the ASTC was increased from 37 to 55. Testing a wall of this size is challenging, however, the wall now functions satisfactorily.

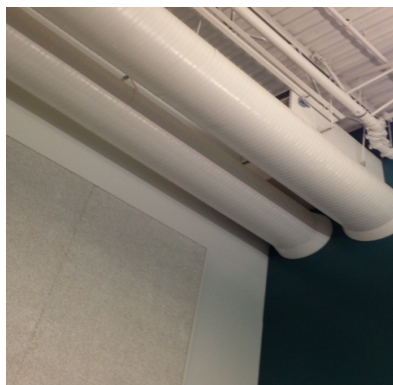
Figure 2 shows the supply air ducts serving the school's performing arts area. The ducts shown are located in the band room. They pass through the wall at the right and continue into the dance and drama studios beyond. This wall had a STC objective of 55, but when first tested it yielded only STC 45. Investigations showed that, while the supply air ducts were round and featured spiral-wound sheet metal, sound created in the band room was able to pass through the duct walls, travel along the duct and pass through the demising wall. There sound was transmitted through the duct walls again and into the dance studio. Music created in the dance studio did the same, but in the opposite direction.

Figure 2: Supply Air Ducts passing between Band Room and Dance Studio.

Several options were considered, including internal duct lining, external duct lagging and silencers. Rather it was decided to build a acoustically-lined gypsum board bulkhead around the two ducts within the band room only. This treatment may be seen in Figure 4. The outcome of this treatment was to increase the ASTC between the band room and dance studio from 45 to 51. However, the ASTC rating would likely have been higher but for the presence of HVAC noise in the dance studio.

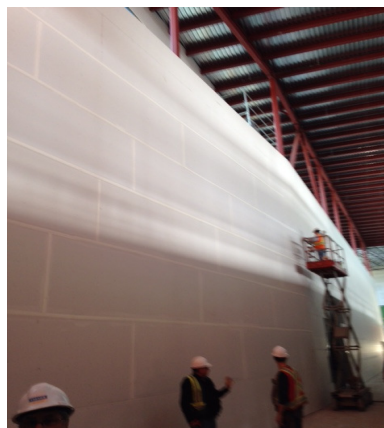
Figure 3: Atrium/Theatre wall under construction - Atrium side.

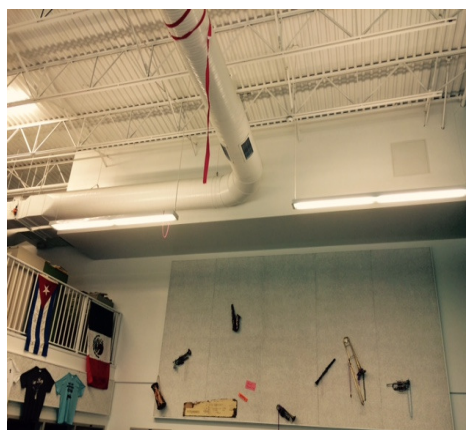
Figure 3: Bulkhead Around Supply Air Ducts in Band Room.
