# TURNKEY SOLUTION PROVIDES NOISE REDUCTION IN MINE VENTILATION SYSTEM

Mehrzaad Salkhordeh\*<sup>1</sup>

<sup>1</sup> dB Noise Reduction® INC., Cambridge, Ontario, Canada

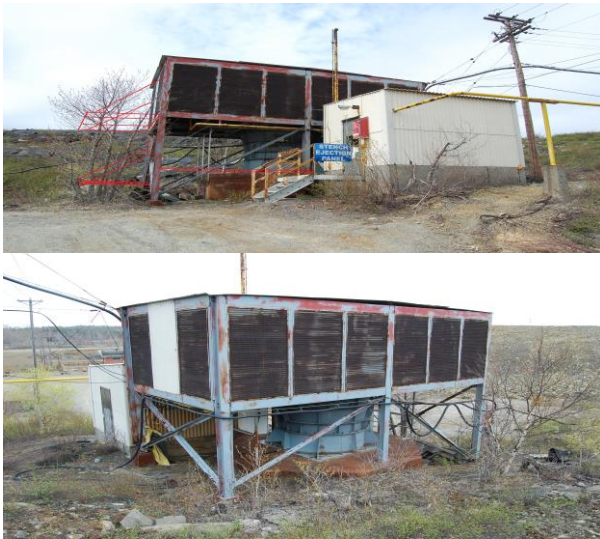
Figure 1: Before the ventilation system

Since mining operations run 24 hours day, seven days per week, the noise levels from the mine ventilation system were an on-going problem in the surrounding areas. Complicating the project was the condition of the existing ventilation enclosure, which was in need of extensive clean up, including the removal of hazardous material.

The dB Noise Reduction® team worked with an acoustical consultant to develop a custom fan silencer solution for the 140,000 ACFM axial fans that were producing a noise level of 104 dBA combined, well above the regulated levels. An integral part of the project included disassembly of the existing steel structure to remove rust and corrugated asbestos. As a noise reduction specialist with an engineering focus, the dB Noise Reduction® team was uniquely qualified to engineer and coordinate all phases of the project, providing a complete turnkey solution.

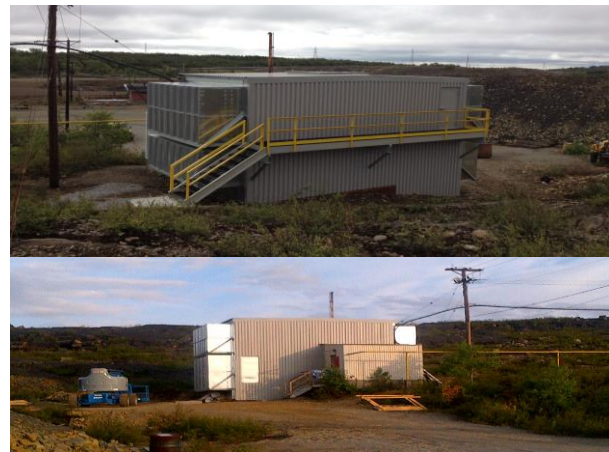
Figure 2: After the ventilation system

The dB Noise Reduction® team addressed all phases of the ventilation system upgrade through a series of operations that were completed within 9 months. For the first step, which was cleaning-up the structural steel, a CO<sub>2</sub> blasting process was used. This avoided the need for environmentally harmful chemicals and eliminated the potential for dust and debris. This was essential in the process, since the fans needed to remain in operation during cleaning. A protective paint was applied to the steel structure.

The next step of the process included special precautions for the removal of the corrugated asbestos. This was the only part of the process during which the mine operation had to temporarily halt operation, due to potential asbestos exposure. The team coordinated the hazardous material removal with a certified removal team, who completed the job in less than a day. Following the excavation of the area, the newly cleaned and treated steel structural was then enhanced with the installation of four fan intake silencers, two acoustic walls, and an acoustic roof.

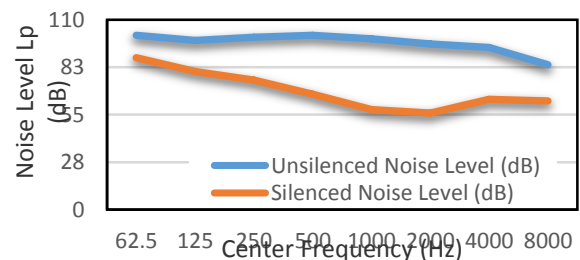
Figure 3: Measurements before and after silencing solution
