UNCOMMON NOISE SIGNATURES IN A WIND TUNNEL

R. Ramakrishnan, M. Rennie and S. Lau Aiolos Engineering Corporation, 2150 Islington Avenue, Toronto, M9P 3V4

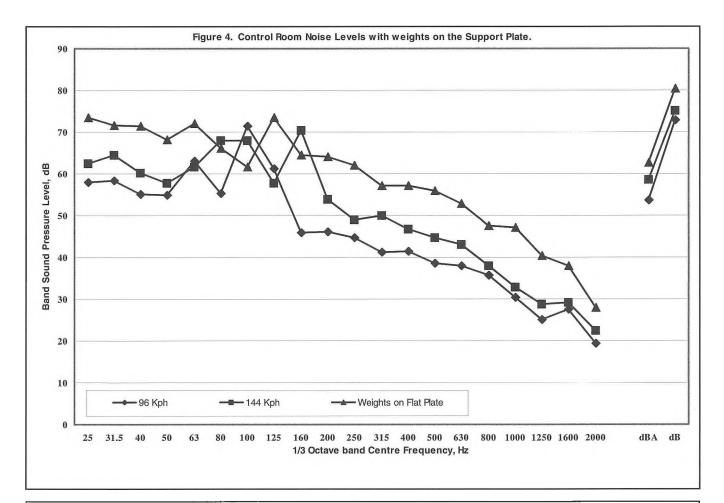
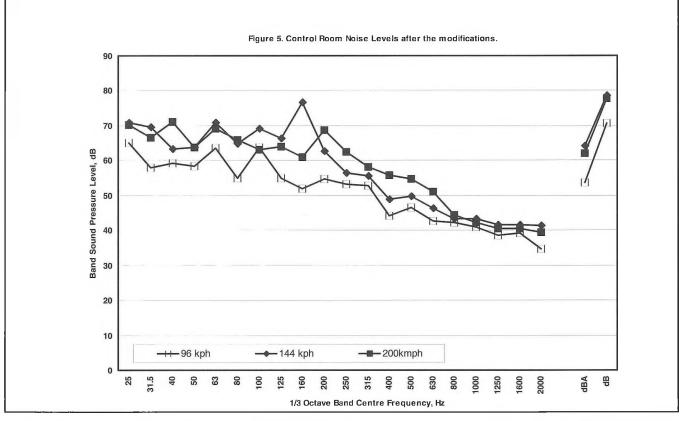
Visual inspection of the fan structure showed, in fact, the close proximity of the stators and support vanes in 1 or 2 locations. Impact tests showed that the support vanes had natural frequencies between 70 to 250 Hz. As a simple test, C-clamps were attached to the affected support vanes so as to modify their natural frequencies; this modification was found to reduce the noise level at the tonal frequency by more than 5 dB (Figure 4). Detailed finite element analysis of the support vanes corroborated that the vanes had transverse mode shapes at the problem frequencies.

Based on the above evidence, it was concluded that the trailing edge flow leaving the stator blades and impinging on the flat support vanes was the main cause of the tonal noise problem. The fan manufacturer was apprised of these findings and the support vanes were modified with additional ribs to change their natural frequencies. The results of these changes are shown in Figure 5 for three operating speeds. The intensity of the tonal noise has reduced substantially and the control room noise levels are within the allowable tolerance of 60 dBA at all speeds.
