# EFFECTS OF STRUCTURAL FLANKING ON APPARENT STC OF STEEL STUD WALL

Clair W. Wakefield, and Andrew P. Williamson

Wakefield Acoustics Ltd., 301-2250 Oak Bay Avenue, Victoria, B.C., Canada, V8R 1G5 email: [nonoise@shaw.ca](mailto:nonoise@shaw.ca)

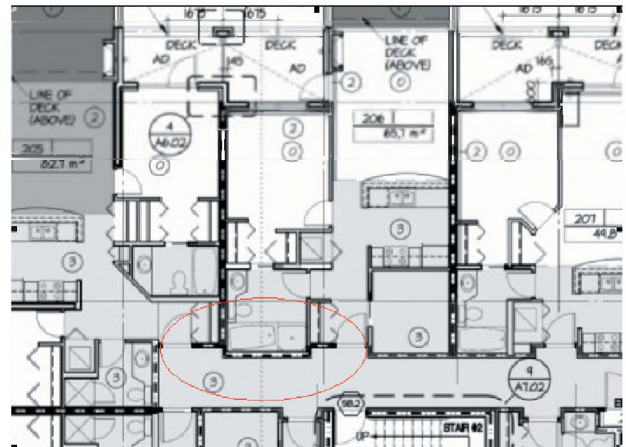
Figure 1; Layout of ASTC Test in Suite 206 showing Corridor Bathroom, Suite 206 Entry to right and Suite 205 Entry to Left.
