# PRACTICAL CONSIDERATIONS OF ONTARIO'S TARION BUILDER BULLETIN 19 ACOUSTICAL REVIEWS FOR NEW CONDOMINIUM BUILDINGS

Nick Walters\*<sup>1</sup> and Darron Chin-Quee†<sup>1</sup>

<sup>1</sup>Novus Environmental Inc., Guelph, Ontario, Canada.

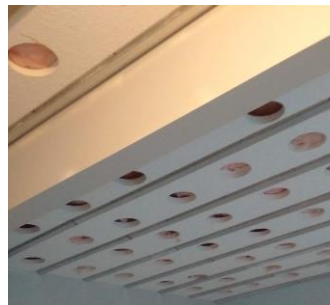
**Figure 1:** RC channel installed with holes for air

**Case 1:** Resilient channel was omitted from the ceiling construction in wooden floor joist separation of stacked townhomes.

**Solution:** As shown in Figure 1, instead of removing the entire GWB ceiling to install the channel, holes were cut in the drywall to allow air movement. Resilient channel was then installed over the existing layers and a new drywall ceiling was added. Performance tests showed expected ASTC levels for the base configuration were met.

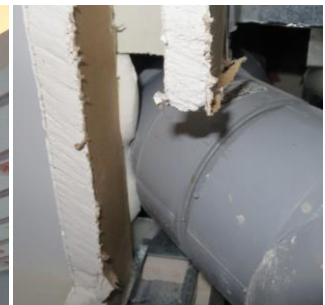
**Figure 2:** Gypcrete rigidly tying stack to bulkhead

**Case 2:** Draining the kitchen sink was a unit was clearly audible throughout the entire living room of the unit below.

**Solution:** Investigation on-site found gypcrete poured above spilled into the bulked head below, rigidly connecting the PVC sanitary stack with the living room bulkhead as shown in Figure 2. This acted as a large plate radiator, with every drop amplified for the tenants below.
